Research Report

Rable substructure guidance

Client	Rable
Document number	12996 (supplemental inspection report Scope 12 Rable substructure)

May 2023

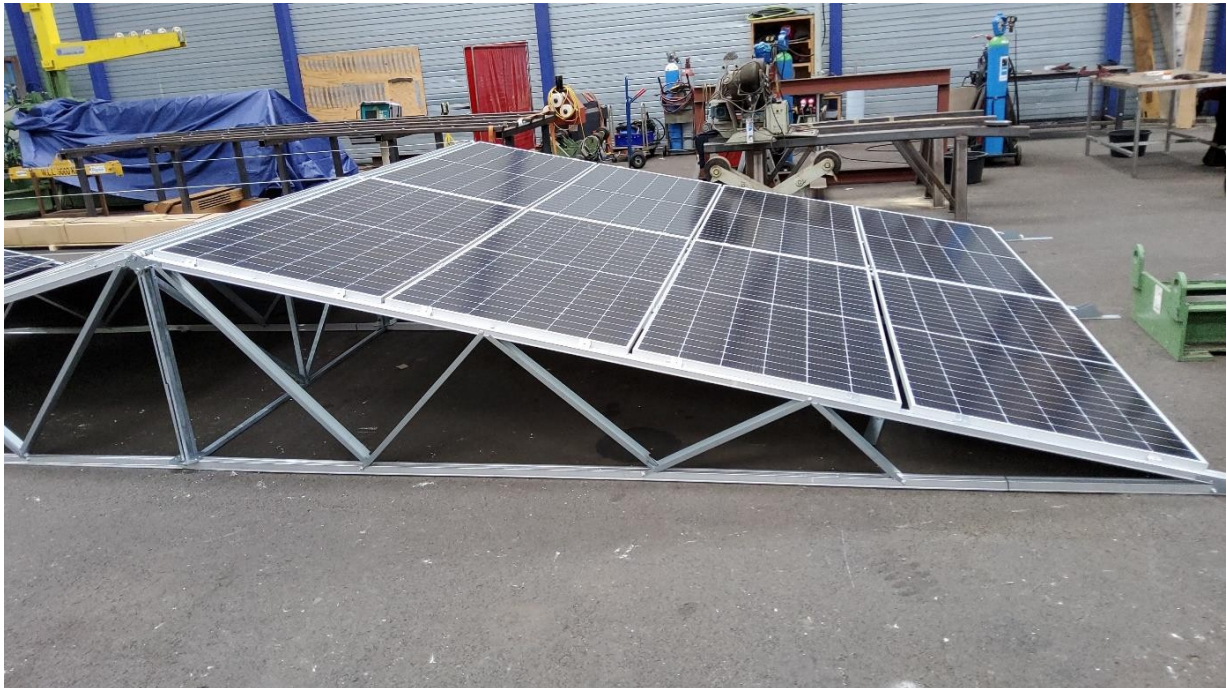
Fig. 1 Indoor test setup

The resistance of the connections to the substructure is 0.07Ω . This is sufficiently low. The resistance of the connection carrier-steel cable is 0.27Ω . This is also sufficiently low.

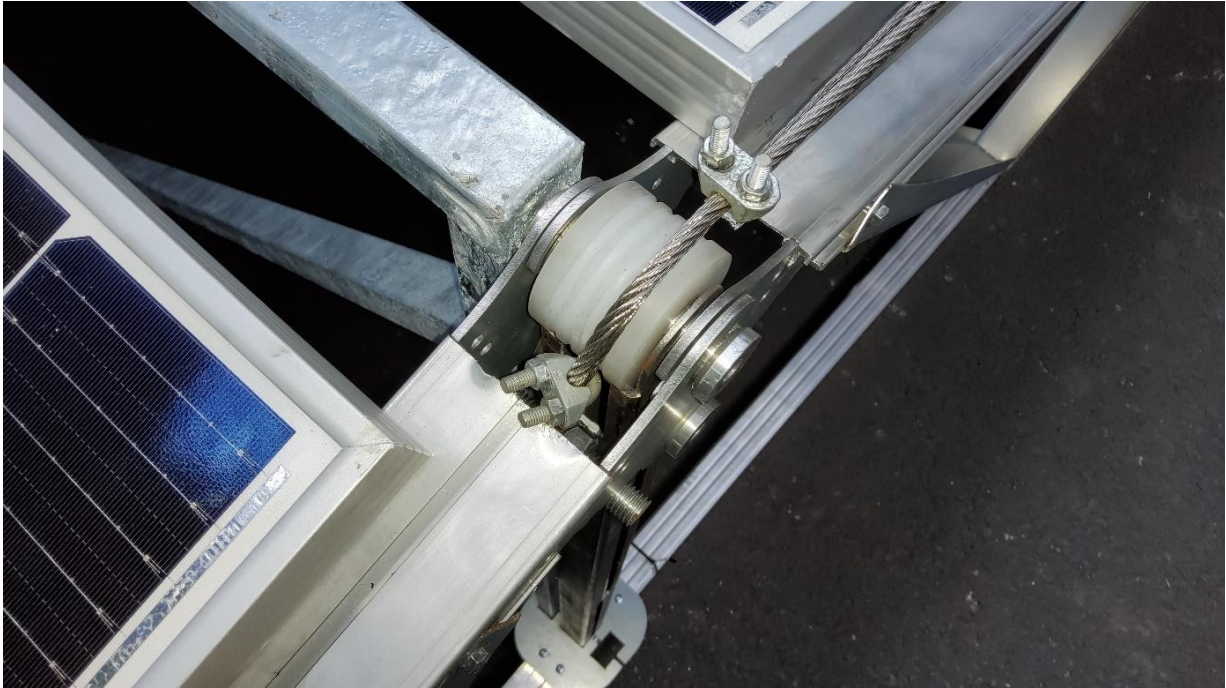
Fig. 2 Sample wire rope connection.

The resistance of all other connections is at most 0.17Ω , again the lower limit of the installation tester's measurement range. The resistance on these connections is sufficiently low.
